Property Inspection Report

Client(s): **Anyone living on Long Island**

Property address: **Anywhere on Long Island**

Inspection date: **Thursday, July 02, 2015**

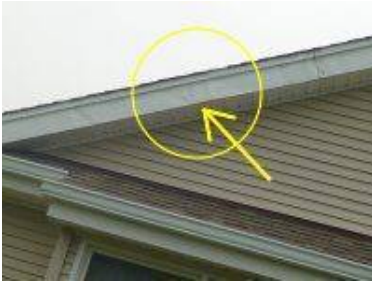
Condition of wall exterior covering: Appeared serviceable with two exceptions: Two aluminum fascia panels appear to be reattached and stressed in front and rear of house. Recommend getting a licensed contractor for repair.

Photo X-1
One of two stressed fascia panels

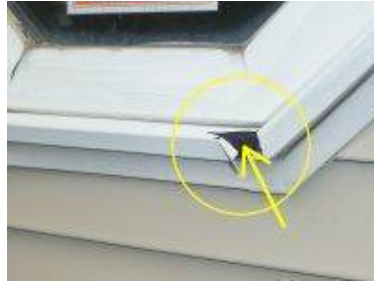
Condition of windows and skylights: Appeared serviceable; One exception is an octagon Captain's window on garage side. Window frame is rotting. Recommend calling a licensed contractor for repair.

Photo X-2
Captain's window on garage side.
Rotting window frame.

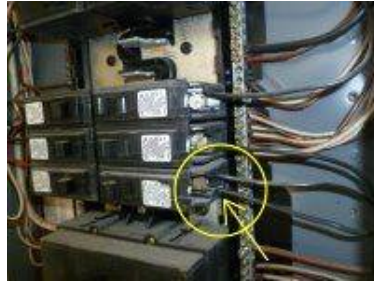
Photo X-4
Double jump on bottom breaker.

Recommend calling licensed Electrician to rectify double jump on a circuit breaker in main electrical box. Refer to photo.

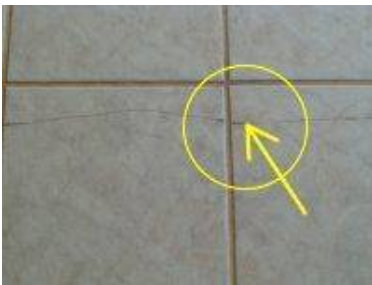
Comments:: One outlet mounted upside down. Recommend licensed electrician to fix. Notice some minor cracking of floor tiles by dishwasher and dining area. Refer to photos. Recommendation: Hire licensed contractor to repair.

Photo X-5
Cracked floor tile in kitchen.

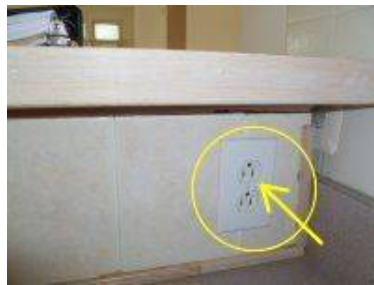
Photo X-6
Outlet mounted upside down.

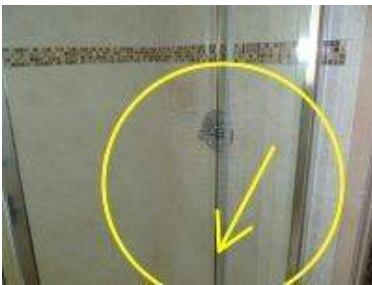
Condition of shower(s) and related plumbing: Location #A, Master Bath, Shower door was not secured. Appeared serviceable, recommendation; need servicing.

Photo X-7
Door guide missing for shower door.

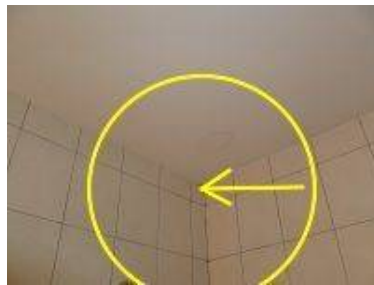
Photo X-8
Small water stain in corner of guest bathroom ceiling.

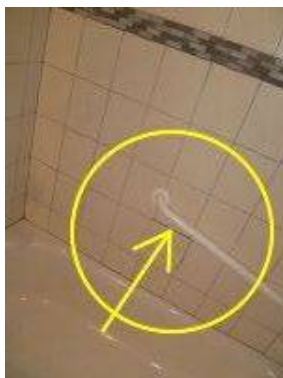
Condition of walls, ceilings & tiles: Location #B, Guest Bath, cracked wall tile, refer to photo and water stain on ceiling over tub.

Photo X-9
Cracked wall tile in guest
bathroom.
